M E M O R A N D U M

1973 SEASON

SERVICE BULLETIN # 1

SUBJECT: HEAVY DUTY SPRING KITS- PARARAIL

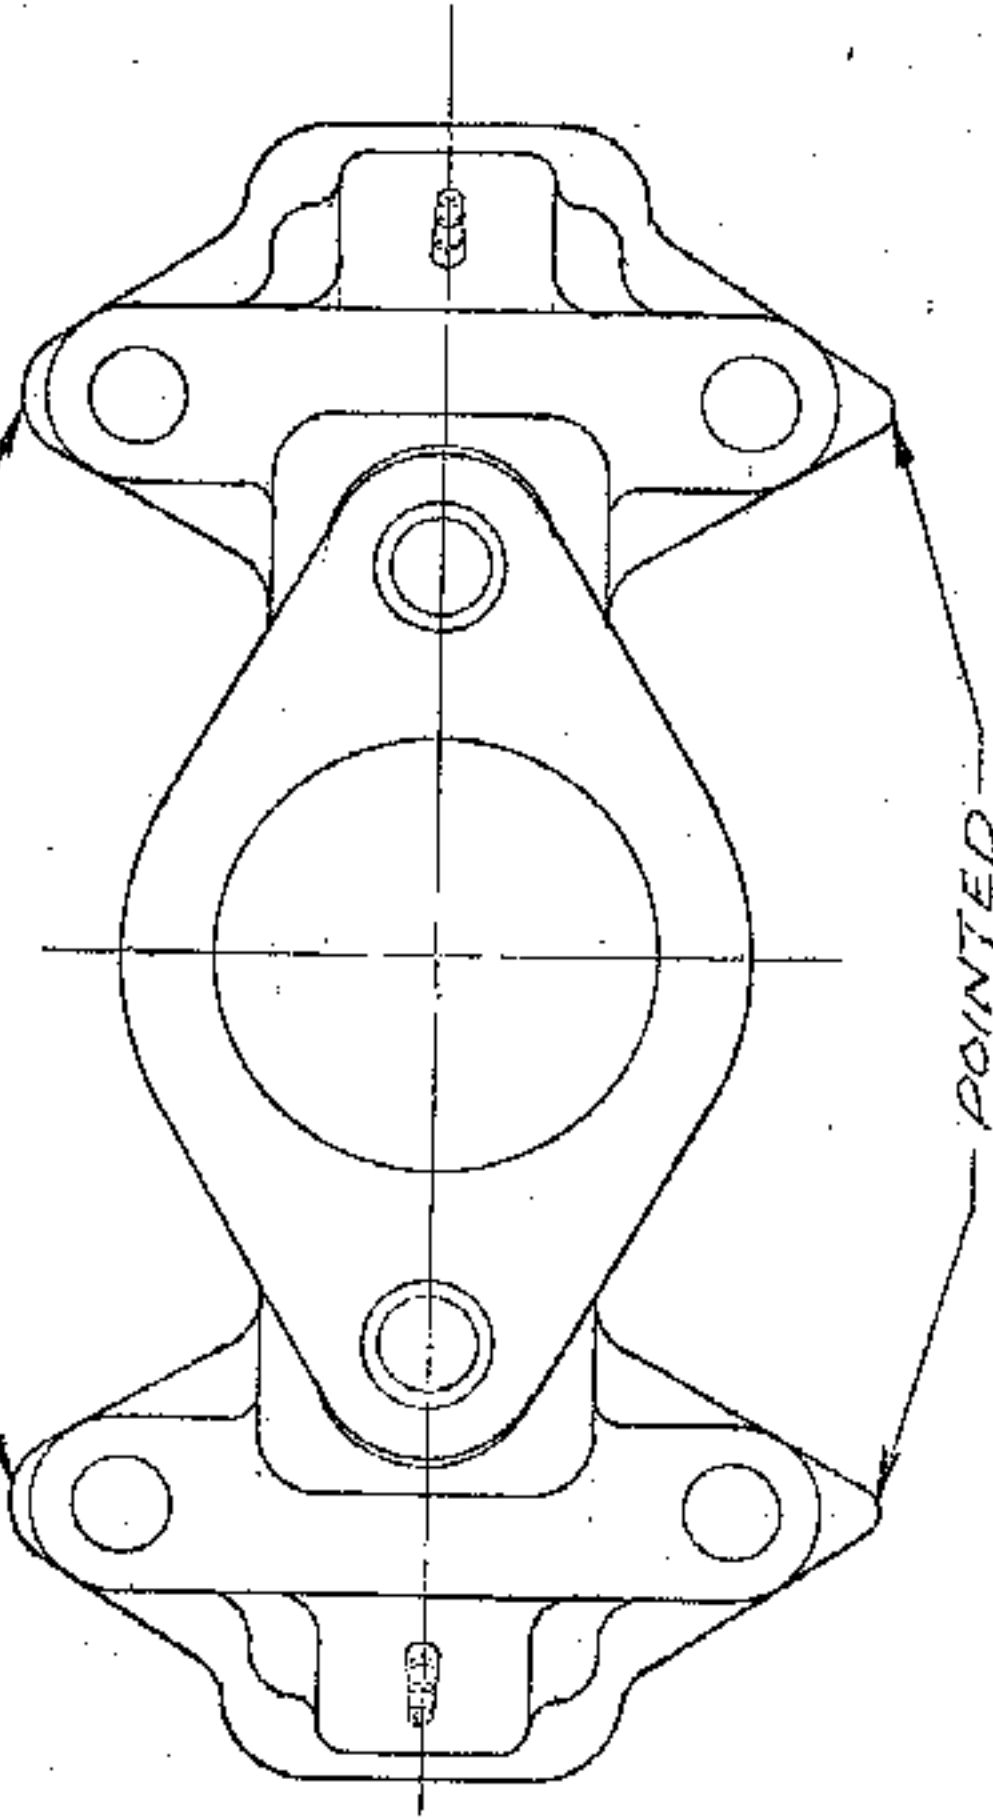
THIS IS TO ADVISE YOU THAT THE INTAKE MANIFOLD ON THE 2F400-6 AND THE 2F440-5 IS DESIGNED SUCH THAT IT CANNOT NORMALLY BE TURNED UPSIDE DOWN ONCE IT HAS BEEN REMOVED AND IS TO BE REINSTALLED ON THE ENGINE. THIS IS TO SAY THAT THE MANIFOLD MUST BE PUT BACK ON IN ONLY ONE POSITION, THAT IS THAT ON THE BOTTOM SIDE OF THE MANIFOLD THERE ARE TWO (2) PROTUSIONS ON THE CASTING BOSS LOWER SIDE. THIS IS SHOWN IN THE ATTACHED DRAWING.

THE REASON FOR THE NON-REVERSIBILITY IS THAT THE PRIMER NIPPLES ARE INSTALLED AT DIFFERENT ANGLES. IT IS VERY IMPORTANT THAT YOU DO NOT INSTALL THE INTAKE MANIFOLD IN THE UPSIDE DOWN POSITION. THIS COULD CREATE A CONDITION THAT THE MANIFOLD WOULD NOT FIT PROPERLY AGAINST THE CYLINDERS, THEREBY ALLOWING AIR TO LEAK AROUND THE GASKET AND THE FLANGE. THIS WOULD CAUSE PISTON AND ENGINE SEIZURE. BE SURE THAT YOU THOROUGHLY UNDERSTAND THIS SERVICE BULLETIN AND THE ATTACHED DRAWING.

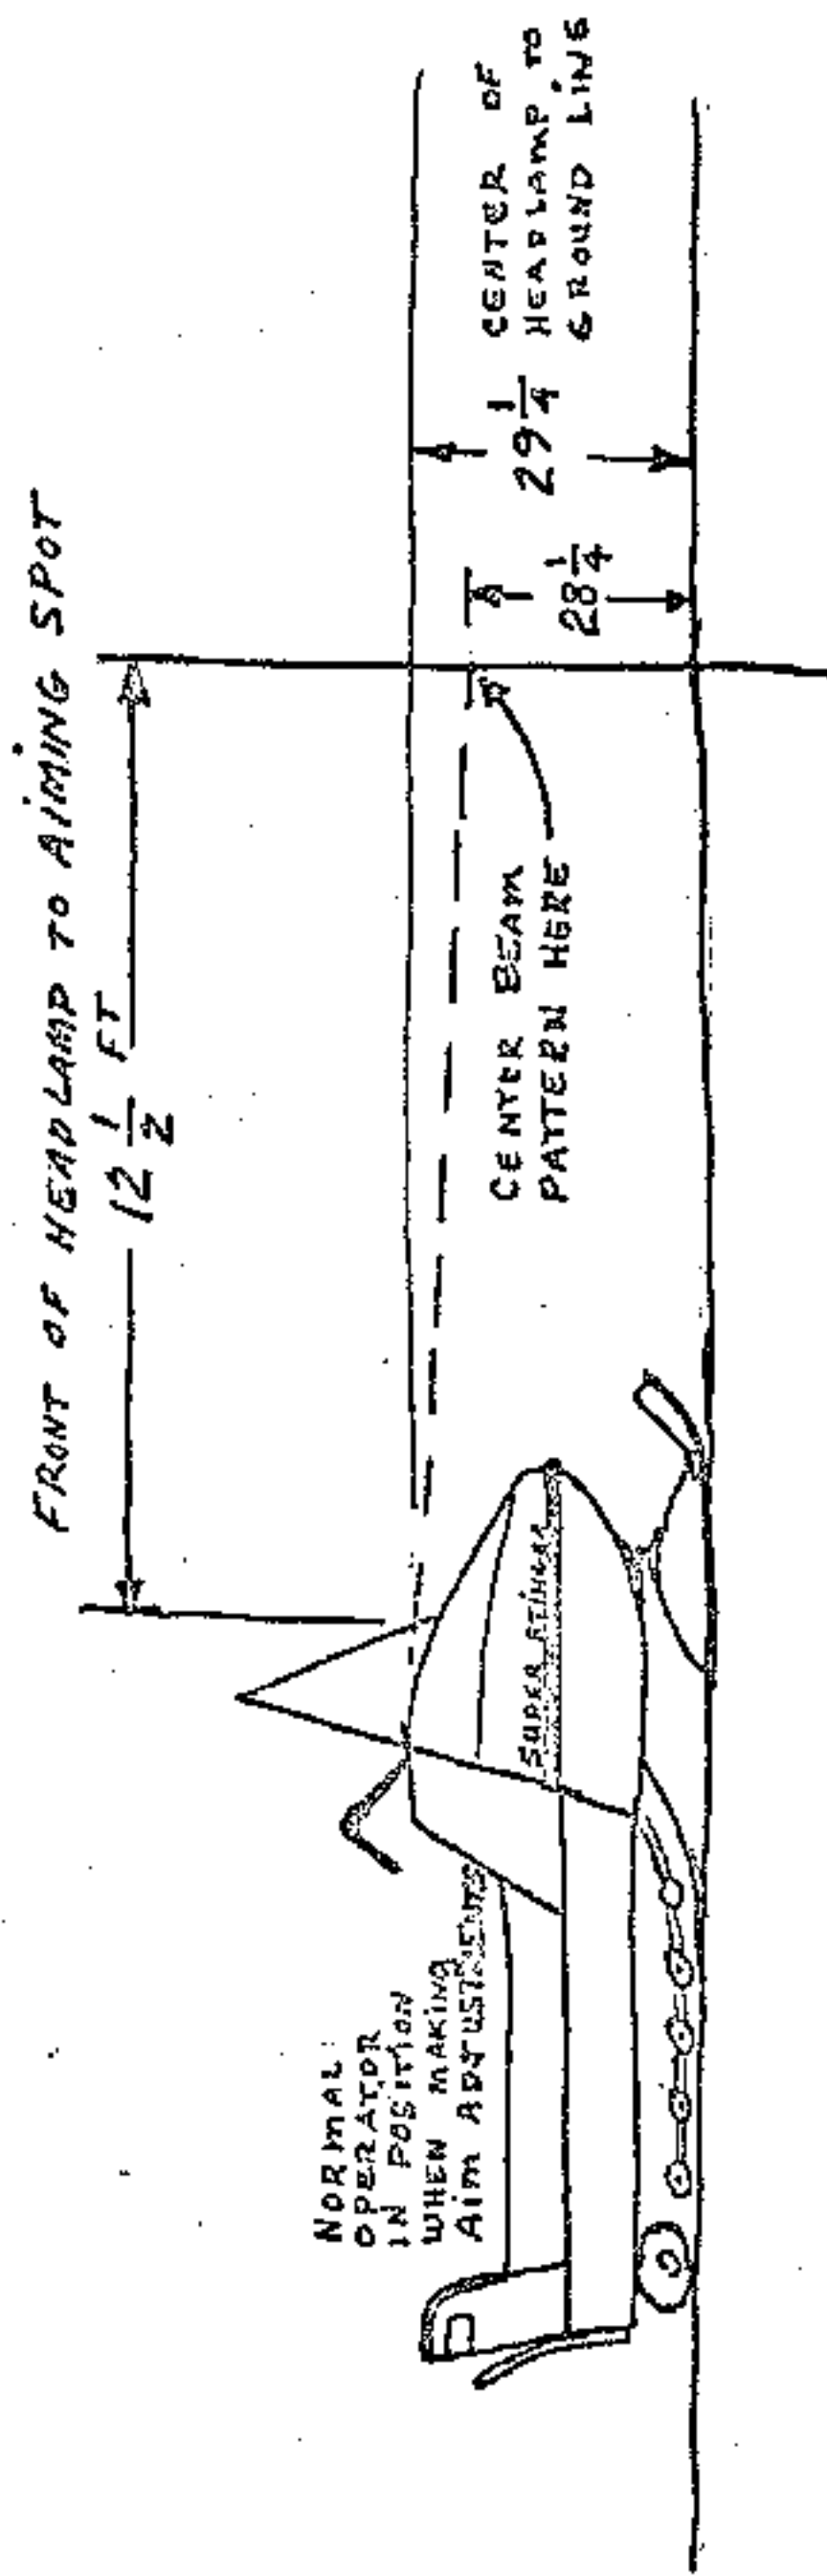
HEADLIGHT AIMING AND ADJUSTMENT

IT IS VERY IMPORTANT THAT THE HEADLIGHT BE PROPERLY ADJUSTED ON EACH MACHINE WHEN IT IS DELIVERED TO THE CUSTOMER. ATTACHED IS A DRAWING AND SPECIFICATIONS FOR HEADLIGHT ADJUSTMENT. THE FOLLOWING STEPS SHOULD BE PERFORMED:

1. PLACE THE MACHINE ON A LEVEL FLOOR WHERE SPECIFICATIONS HAVE BEEN LAID OUT ACCORDING THE ATTACHED DRAWING.
2. CHECK TO MAKE SURE THAT THE COWL FITS PROPERLY AGAINST THE STOPS (ROLL BAR). THE HOOD MAY BE LEFT LOOSE DURING THE ADJUSTMENTS PROCEDURE BUT MUST BE IN THE "CLOSED" POSITION WHEN CENTER BEAM POSITION IS CHECKED.
3. HAVE THE CUSTOMER SIT ON THE MACHINE IN THE NORMAL OPERATING POSITION.
4. START THE MACHINE AND IDLE THE ENGINE AT 2,000 RPM.
5. PLACE THE HIGH/LOW SWITCH IN THE "HIGH" POSITION.
6. ADJUST THE HEADLIGHT SO THAT THE CENTER BEAM PATTERN IS IN THE PROPER POSITION ON THE WALL OR SCREEN (28'- $\frac{1}{2}$ " INCHES) NOTE: ALL FOUR (4) SCREWS MAY HAVE TO BE ADJUSTED TO ACHIEVE THE PROPER HEADLIGHT ADJUSTMENT CENTER BEAM PATTERN.

THE HEADLIGHT IS NOW ADJUSTED PROPERLY. THE CANOLE POWER REQUIREMENT AT THE PROPER DISTANCE, AS IS REQUIRED BY CANADA AND THE UNITED STATES, WILL NOW BE WITHIN THE PRESCRIBED SPECIFICATIONS.
